UNITED STATES DISTRICT COURT SOUTHERN DISTRICT OF NEW YORK	DOCUMENT ELECTRONICALLY FILED DOC #: DATE FILED: January 23, 2018
IN RE M/V MSC FLAMINIA	: 12-cv-8892 (KBF) : 12-cv-8892 (KBF) : CORRECTED : OPINION & ORDER¹X

# KATHERINE B. FORREST, District Judge:

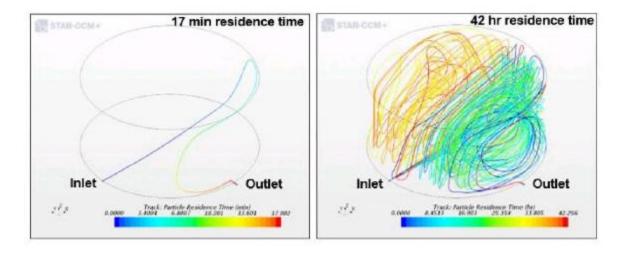
Figure 2.

(Id. at 40–41, ¶ 119.) Figure 2 depicts the path and residence time of massless tracer particles. <sup>19</sup> (Id.) The left diagram depicts the path of the tracer particle that stayed in the tank for the shortest amount of time, 17 minutes; the right diagram depicts that path of the tracer particle that stayed inside the tank for the longest amount of time, 42 hours. From this experiment, Dr. Davis concluded that particles in the MV-804 tank completely mix from top-to-bottom in the tank and that there is no evidence of stagnant layering (that is, no DVB80 liquid remaining in one place without mixing with TBC and oxygen). The mixing ensured that there were near homogenous oxygen levels at all layers (that is, heights within the tank), and that

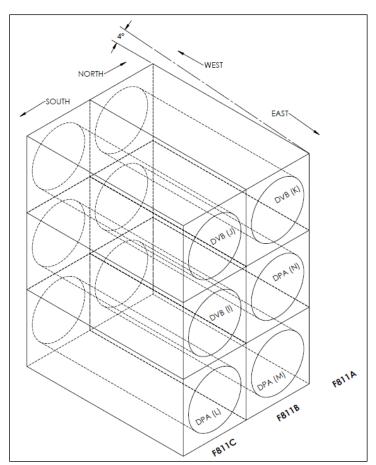
Figure 4.

(Davis Decl. at 17, ¶ 9.) As evidenced from the diagram, while on the dock at NOT, Tank I was exposed to thermal radiation from three neighboring ISO containers filled with heated DPA: Tanks L, M, and N.

The conditions in which the ISO container in the Willbros Study was placed did not approximate those at NOT or aboard the Flaminia. First, and most significantly, the ISO container was never placed out in the open, where solar radiation would directly hit a portion of the container, and the container would be exposed to ambient temperatures that fluctuated into the 90s (Fahrenheit). Second, when in the warehouse, the container with DPA was not proximate to any other containers with heated DPA that might have emitted some heat. When both on the dock at NOT and in storage aboard the Flaminia, the ISO containers filled with DPA were proximate to one another. For instance, DPA (N) was directly below DVB (K), and directly adjacent to DVB (I). DVB (I) was also directly above another container with DPA, DPA (L). DPA (M) and DPA (N) were each diagonal from DVB (I) and (J), respectively. (See fig. 4.)

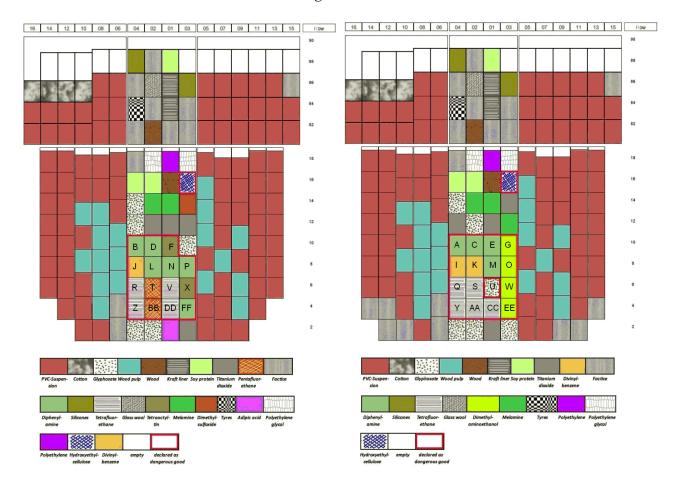
Figure 5.

(Id. at 22, ¶ 31.) This diagram shows that in Hold 4, Tank J was surrounded on two sides by Tanks B and L, and diagonal to Tank D, all of which contained DPA. Similarly, Tank A—of heated DPA—was stored directly on top of the least insulated portion of Tank I, and Tank C was diagonal to it; Tank K had top, side, and diagonal DPA containers.
